HUMAN KINEMATICS DURING NON-COLLINEAR LOW VELOCITY REAR END COLLISIONS

Whitman E. McConnell, Herbert M. Guzman, Scott W. Krenrich, John B. Bomar, Jr., Richard M. Harding, James H. Raddin, Jr., and James R. Funk
Biodynamic Research Corporation
San Antonio Texas, USA

ABSTRACT

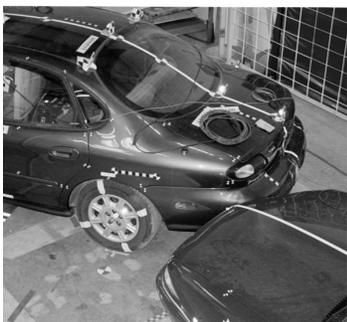
Fig. 1 - Staged Non-Collinear LVRE Collision

These events happen during intersection and parking lot impacts that can occur, for example, when the leading (angled) vehicle turns onto an intersecting lane, unexpectedly slows or stops, and is struck from behind by the following vehicle (Fig. 1).

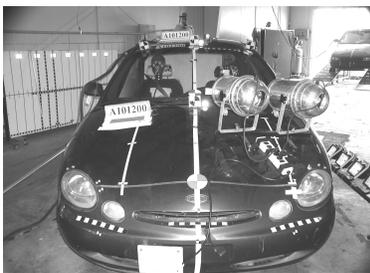
Fig. 2 - Test Area and Vehicle Orientation

The indoor test area is housed in a warehouse building with a large doorway leading to an indoor-outdoor steel ramp allowing up to a 2.4 m (8 ft) elevation above the test area floor (Fig. 2).

The 12 degree incline provides a method of controlling the striking

vehicle's energy. A 9.1 m (30 ft) roll out zone prior to the impact point allowed vertical perturbations of the striking vehicle to cease before impact. By using the same starting position on the ramp for each test, similar impact velocities were achieved (all within 12.0 ± 0.4 kph (7.45 ± 0.25 mph)). The car to ground coefficient of friction of the struck Ford was measured by dragging the vehicle over the test area floor.

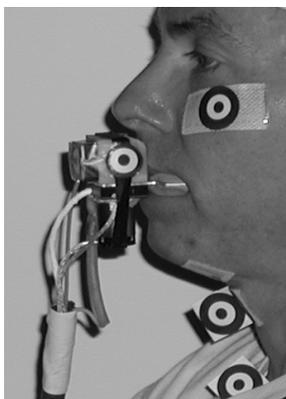
Fig. 4 – Transducer & Marks

ELECTRONIC DATA ACQUISITION - For all tests, the subjects were instrumented with bite blocks (Fig. 4) rigidly located with respect to the skull. Three mutually orthogonal linear accelerometers were mounted on each bite block to measure fore-aft (G_x), lateral (G_y), and vertical (G_z) acceleration. The block also housed two rate sensors to measure head pitch (ω_y) and yaw (ω_z) angular velocities (i.e. in the sagittal and transverse planes, respectively).
