Occupant Ejection Trajectories in Rollover Crashes: Full-Scale Testing and Real World Cases

Reprinted From: **Accident Reconstruction, 2008**
(SP-2160)

2008 World Congress
Detroit, Michigan
April 14-17, 2008

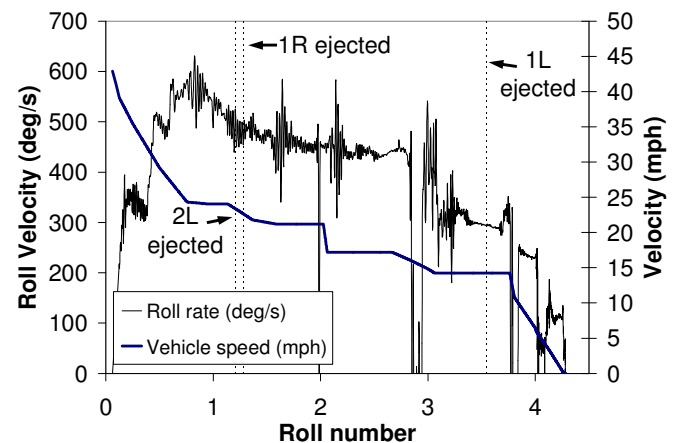
Figure 1. Translational vehicle velocity and roll rate vs. roll number for the Volvo XC90 dolly rollover test. Ejection points for each ATD are shown.

The 2004 Volvo XC90 rolled over driver side leading 4 ¼ times over a distance of 103 feet beyond the end of the initial tire marks. Continuous time histories were calculated for the translational velocity, position, roll rate, and roll angle of the vehicle (Figure 1). There was significant pitch and vertical motion of the vehicle in the middle of the third and fourth rolls, and significant yaw during the final roll. A detailed description of the vehicle dynamics and a scene diagram can be found in Luepke et al. [4].

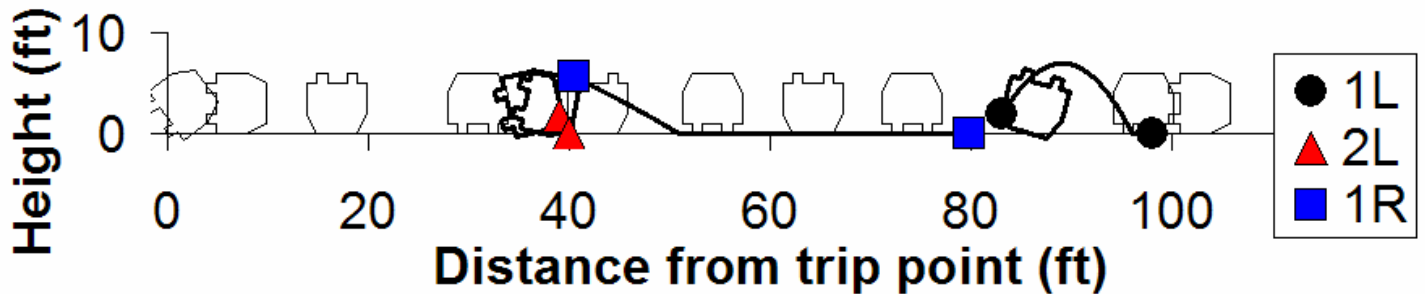
Figure 2. Illustration of the trajectories of the three dummies ejected in the Volvo XC90 dolly rollover test.

Three out of the four unbelted ATDs were fully ejected from the Volvo during the rollover (Figure 2). One ATD (2R) remained in the vehicle. The three ejections in this test were quite varied. One of the ATDs (1L) was ejected on the “high” side, meaning that it left the vehicle with an initially upward trajectory. This ATD was ejected behind the vehicle near the end of the rollover. Two of the ATDs (1R and 2L) were ejected on the “low” side, meaning that they left the vehicle with an initially downward trajectory. Both of these ATDs were rolled over by the vehicle after being ejected. ATD 1R was thrown downward violently into the ground ahead of the vehicle and bounced approximately 4 feet into the air.

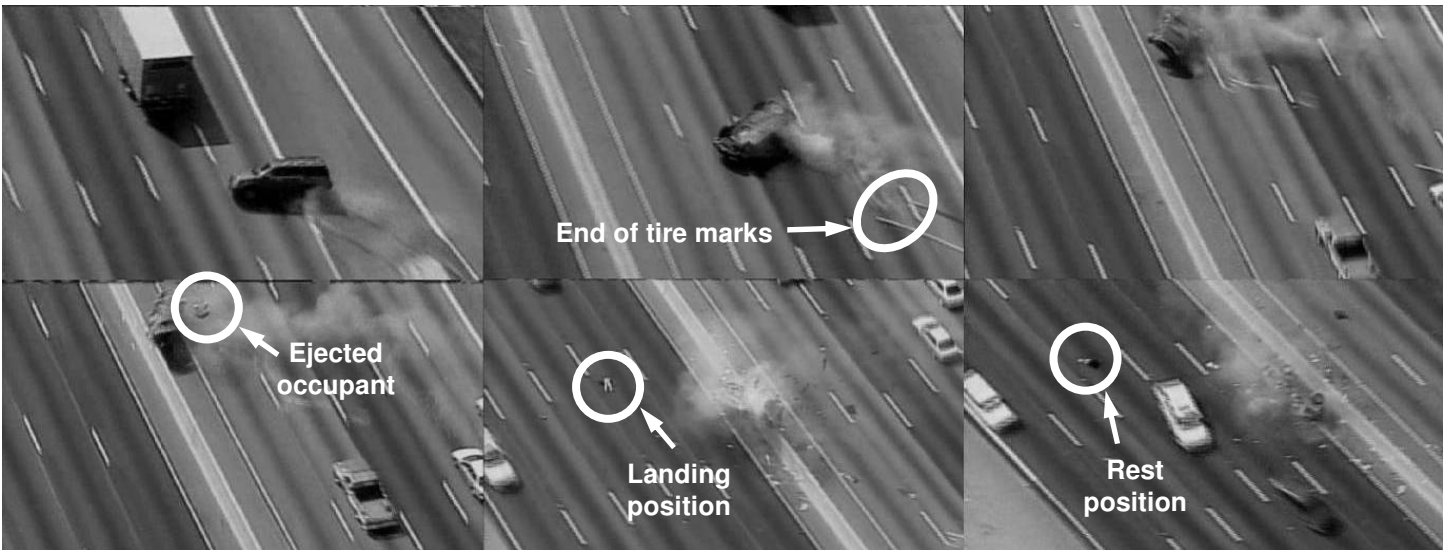
Figure 3. Sequence of video images for the Lincoln Navigator rollover.

It was possible to obtain vehicle and occupant positions by analyzing individual frames from the video (Figure 3). Key video images were rectified, spliced together, and overlaid on an aerial image of the accident scene (Figure 4). This information was used to create a scaled scene diagram (Figure 5). Positions of the vehicle and corresponding times were used to calculate the average translational velocity between positions and create a translational velocity vs. time plot (Figure 6). The roll angle vs. time plot (Figure 6) is the same information that was previously published in Figure 6 of Rose et al. [5]. Using optimized values for the launch radius and friction coefficient, the model was able to match the observed ejection trajectory almost exactly (errors < 1 ft, 1 mph, and 1 deg) (Figure 7).

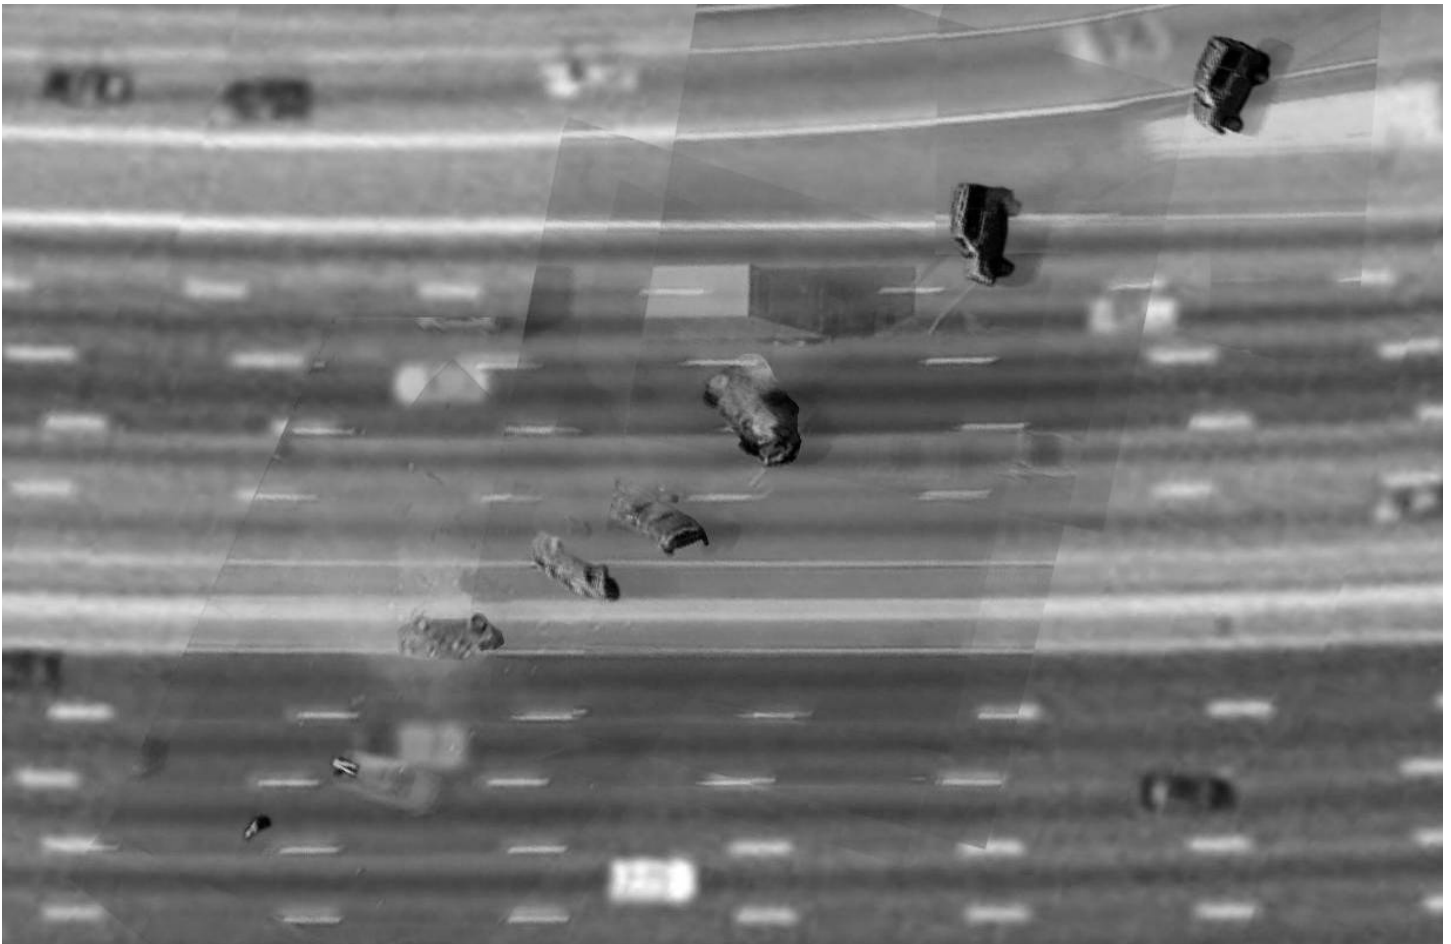
Figure 4. Rectified video images from the Lincoln Navigator rollover overlaid on an aerial photograph. Key vehicle and occupant positions have been highlighted.

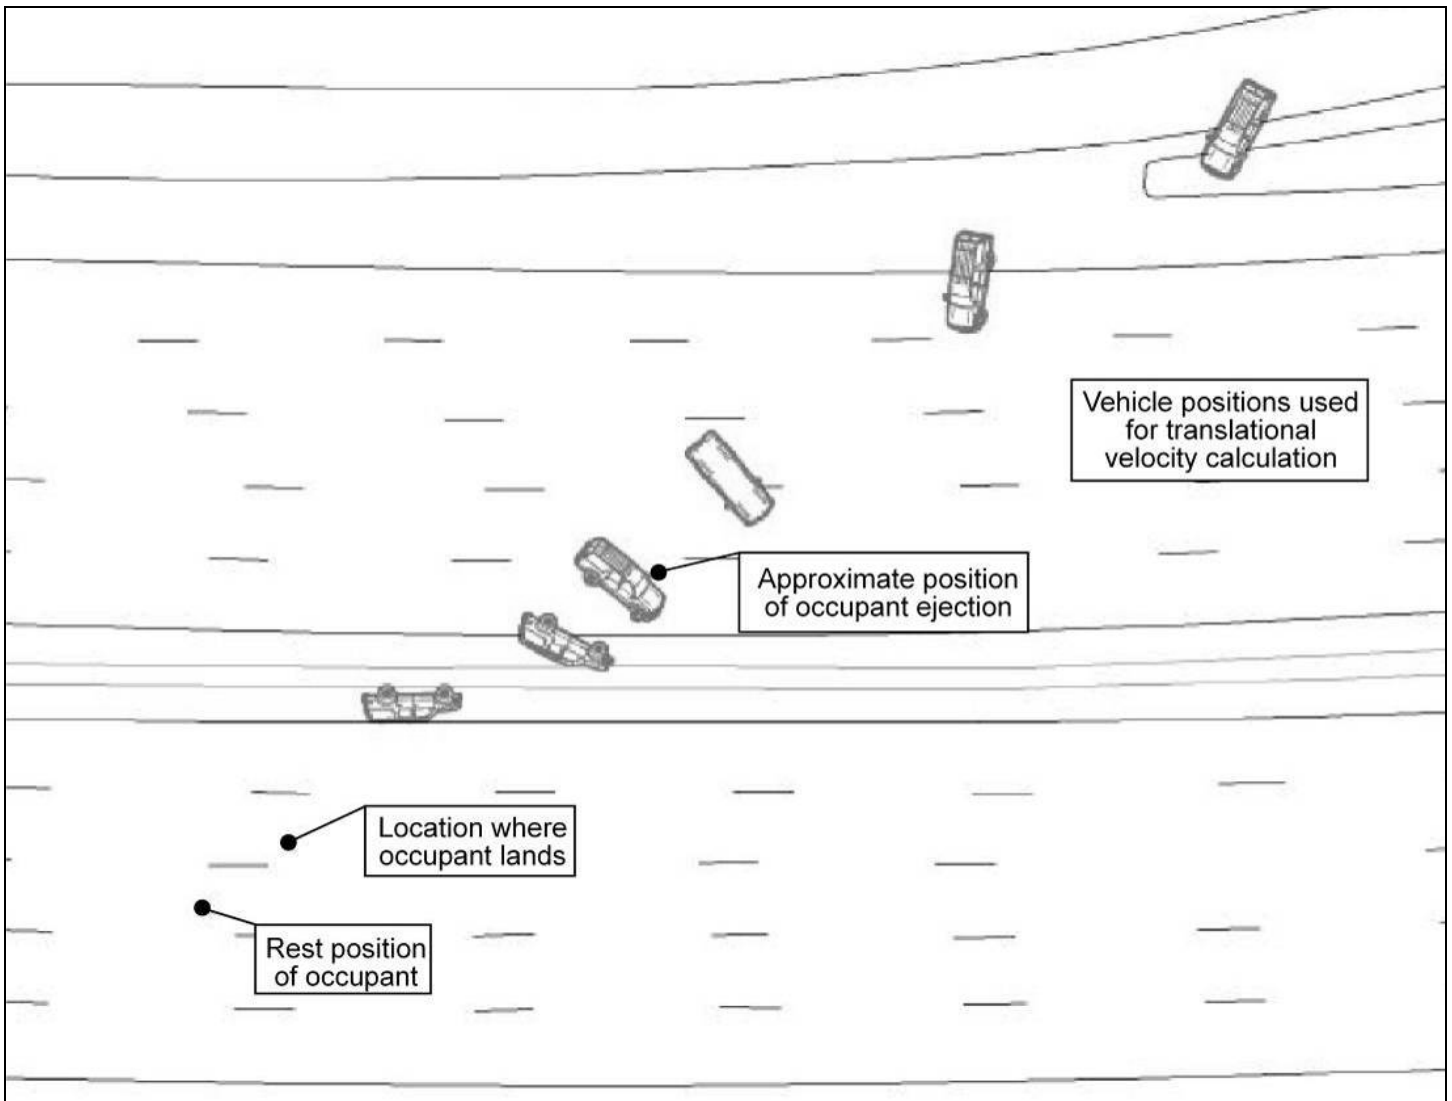
Figure 5. Scene diagram for the Lincoln Navigator rollover.

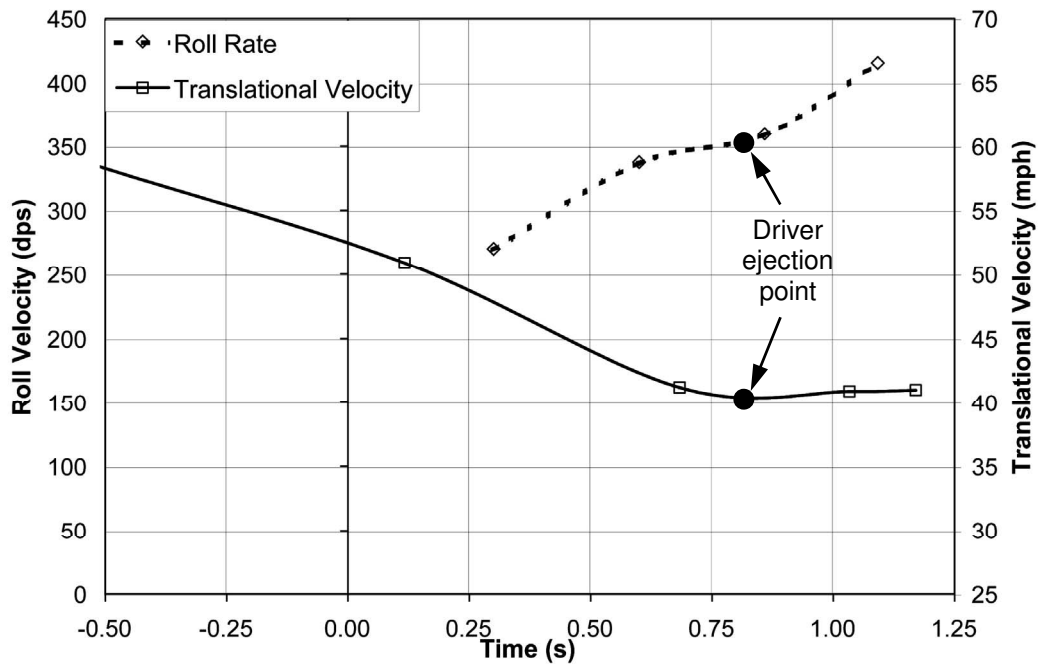
Figure 6. Roll rate and translational velocity for the Lincoln Navigator rollover.

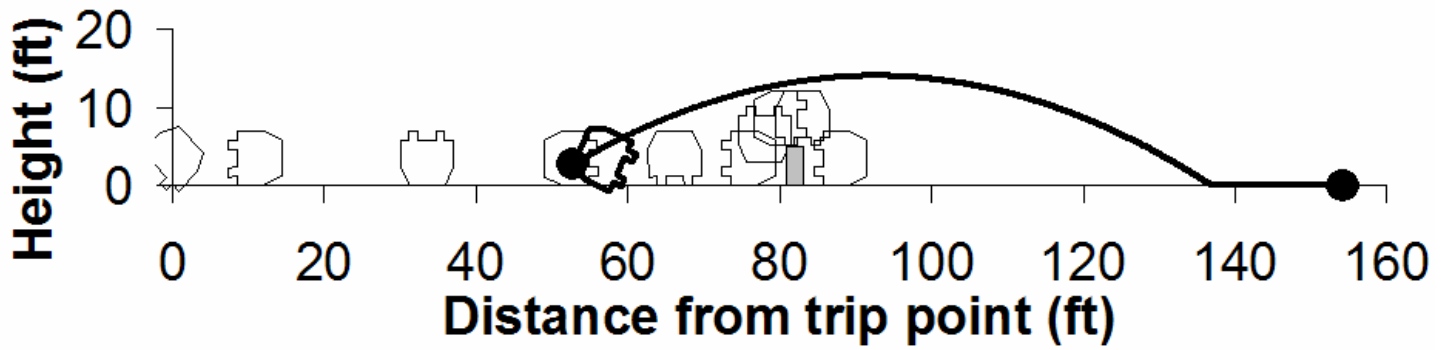
Figure 7. Illustration of the trajectory of the ejected occupant in the Lincoln Navigator rollover.

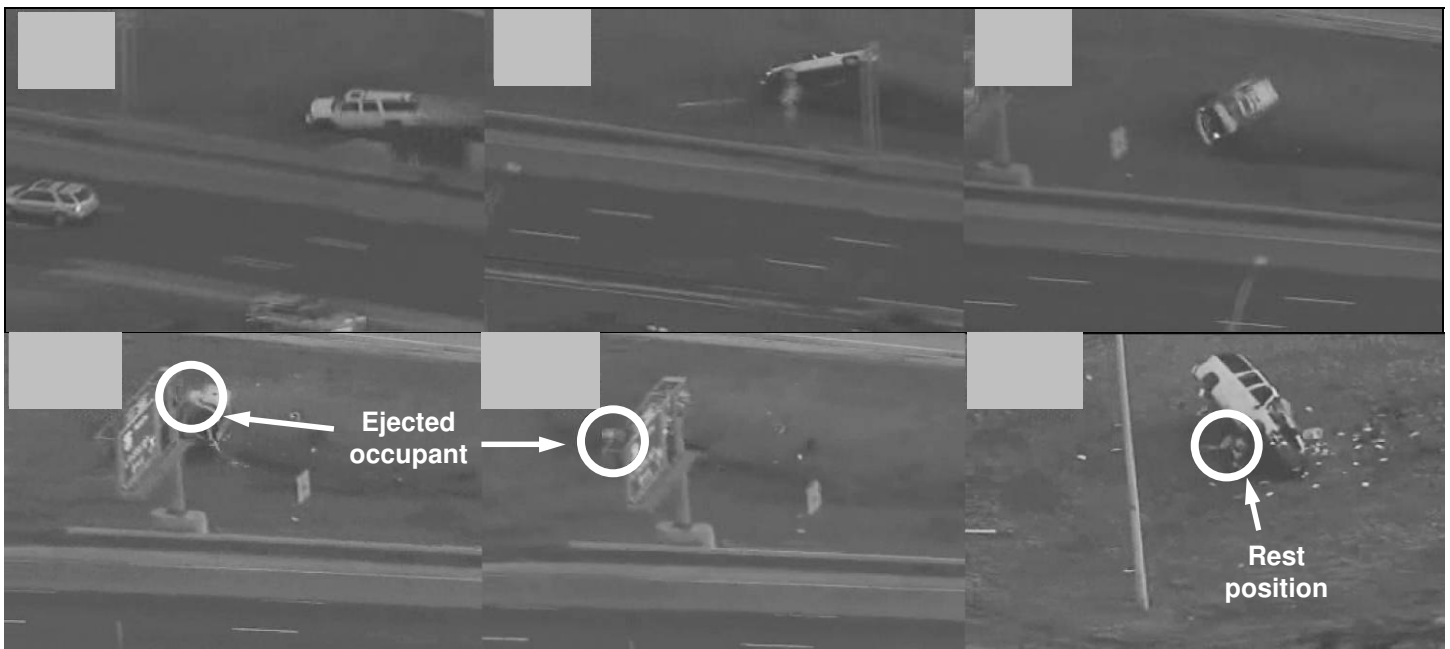
Figure 8. Sequence of video images from the GMC Yukon Denali rollover.

Vehicle and occupant positions were obtained with good accuracy by analyzing individual frames that contained landmarks visible in both the video and the aerial image (Figures 8 – 10). By analyzing the speed of the vehicle over a long distance before the crash, it was confirmed that the vehicle was traveling over 100 mph, as stated in the audio from the news helicopter footage (Figure 11). The average deceleration of the rolling vehicle from the end of the tire marks to rest was 0.53 g. Using optimized values for the launch radius and friction coefficient, the model was able to match the observed ejection trajectory almost exactly (errors < 1 ft, 1 mph, and 1 deg) (Figure 12).

The release angle at which an occupant is ejected from the vehicle is important because it relates to the severity of the landing. A release angle of 270° would represent a pure deposit, the least violent ejection possible. A release angle near 0° will generate the greatest ejection height and longest throw distance for a given translational and rotational velocity (e.g., ATD 1R in the Expedition dolly rollover). A release angle near 180° will produce an equally severe landing with a very short throw distance. Low side ejections in which the ejected occupant is thrown downward are associated with release angles of $90^\circ - 270^\circ$ (quadrants 2 and 3). In low side ejections, there is a substantial risk that the vehicle will roll over the occupant after the ejection occurs. At release angles of $180^\circ - 270^\circ$ (quadrant 3), the occupant is thrown downward and behind the vehicle while still in front of the vehicle, making subsequent contact with the vehicle very likely (e.g., ATD 2L in the Volvo dolly rollover). Even in low side ejections where the occupant is thrown ahead of the vehicle at release angles of $90^\circ - 180^\circ$ (quadrant 3), there is a significant risk that the vehicle will catch up to and roll over the occupant. The ejected occupant can lose a significant amount of speed upon landing, and will then tend to decelerate at a faster rate than the vehicle. In four out of the five low side ejections studied, the vehicle rolled over the occupant after the occupant was ejected (Table 2). The exception was the Denali rollover, and in that case the vehicle came very close to rolling over the occupant (Figure 8).

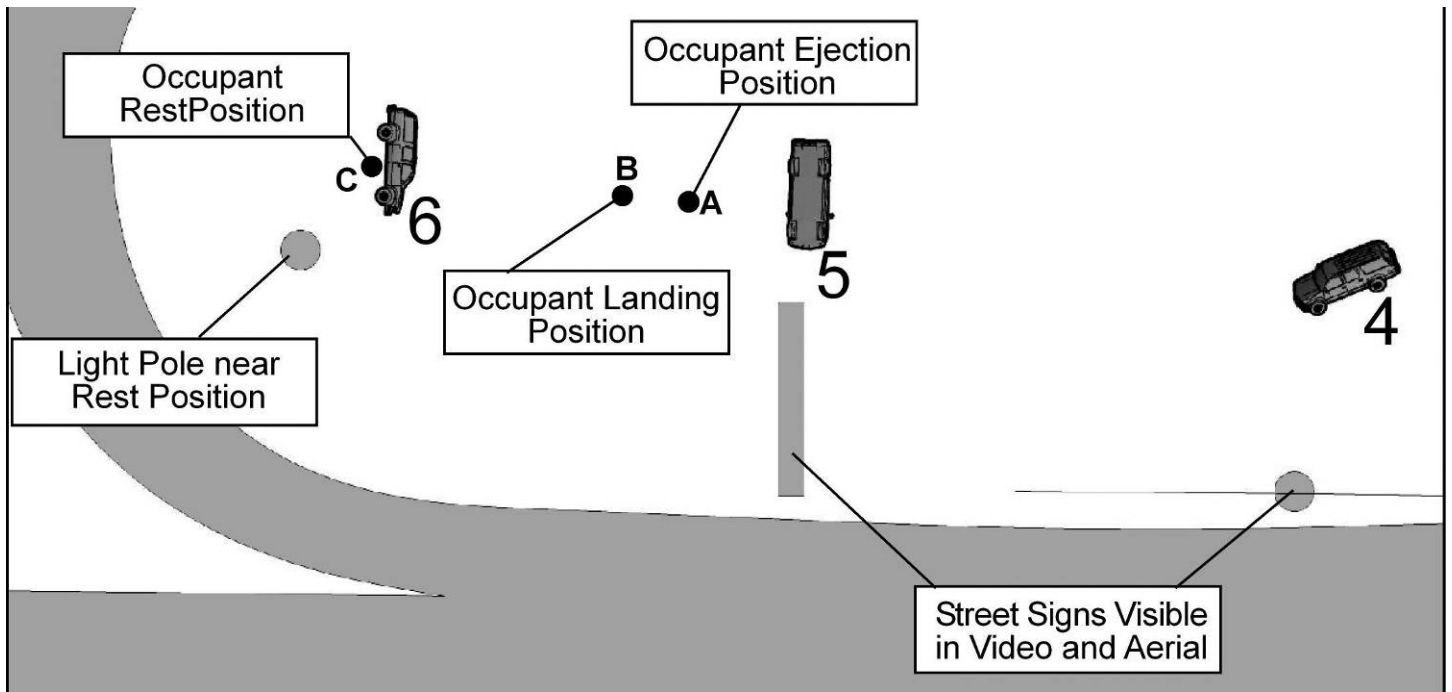
Figure 10. Scene diagram for the GMC Yukon Denali rollover.

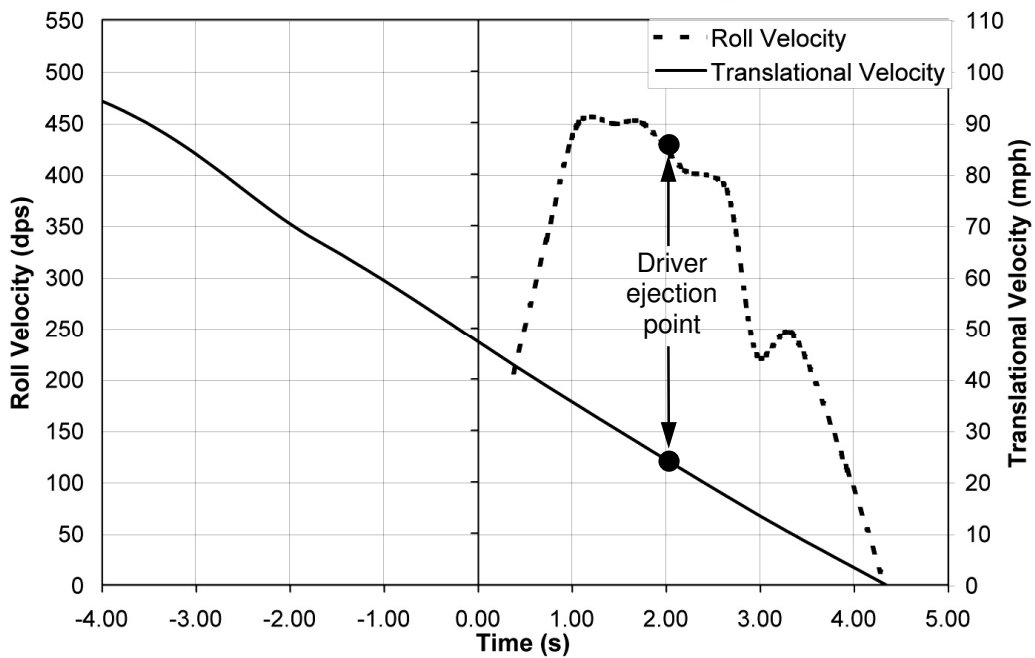
Figure 11. Roll rate and translational velocity for the GMC Yukon Denali rollover.

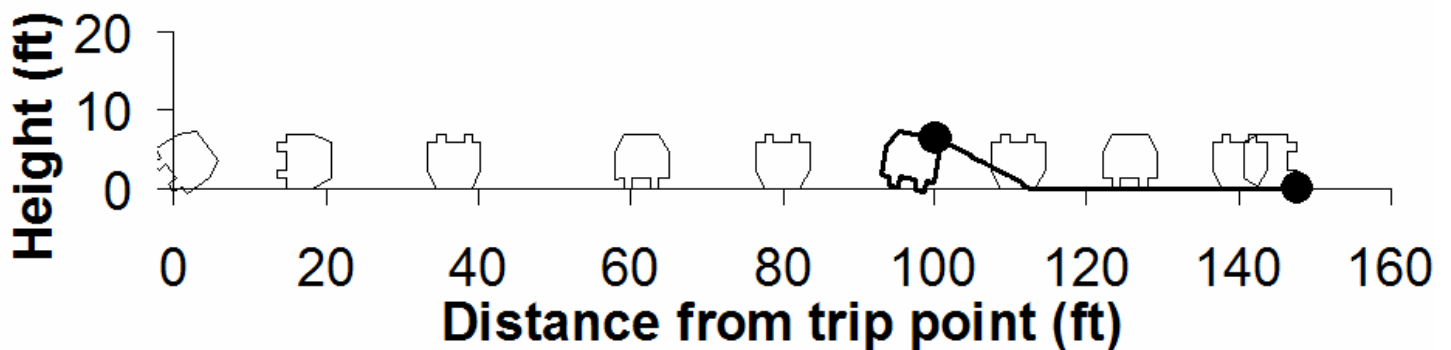
Figure 12. Illustration of the trajectory of the ejected occupant in the GMC Yukon Denali rollover.

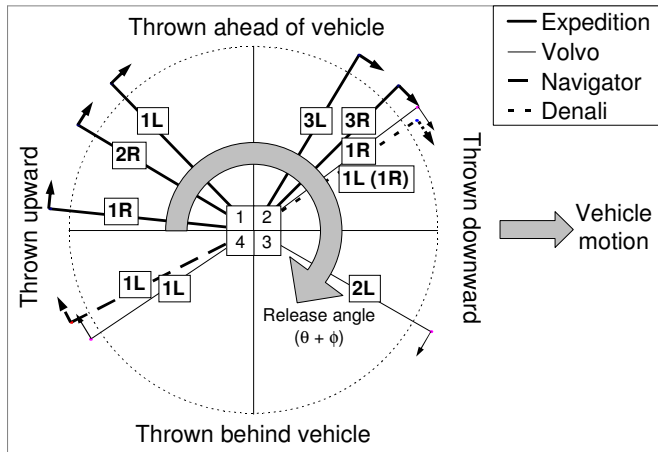
Figure 13. Release angles for each ejected occupant. Release quadrants are labeled 1 – 4.

The occupant ejection kinematics in the two real world rollover crashes did not appear to differ from the ATD ejection kinematics in either the Volvo XC90 dolly rollover test or the Ford Expedition dolly rollover test studied previously [3]. The release angles in the real world rollover ejections were consistent with the range of release angles observed in the dolly rollover tests (Figure 13). The release angle was defined as the roll angle of the vehicle (θ) plus the angle of the occupant's portal of ejection relative to the lateral axis of the vehicle (ϕ), which is nominally 130° for the leading side roof rail and 35° for the trailing side beltline [3].

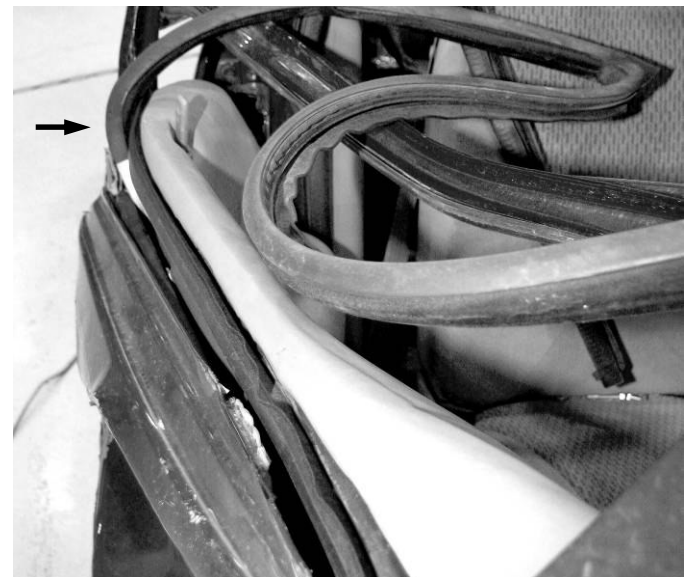
Figure 14. The right front door panel was bowed outward due to loading from ATD 1R in the Expedition rollover test.

Inspection of the dolly rollover test vehicles revealed pronounced and distinctive marks in most, but not all, of the window openings through which an ATD was ejected. Interestingly, similar marks were sometimes found on window openings through which an ATD was only partially ejected. There was sometimes outward bowing of the door panel or window frame due to loading from an ejected occupant (Figures 14 – 15). Surfaces on the perimeter of the ejection portal were almost always scuffed, polished, or abraded (Figures 16 – 19). In many instances, the abraded material was smeared in an outboard direction (Figures 17 – 18). Fabric marks consisting of closely spaced parallel abrasions were clear evidence of contact from a clothed portion of the ATD (Figures 18 – 19). Exit marks were found in various places around the perimeter of the ejection portals, but the marks tended to be heavier and more numerous on the lower portion of the trailing side ejection portals and on the upper portion of the leading side ejection portals.

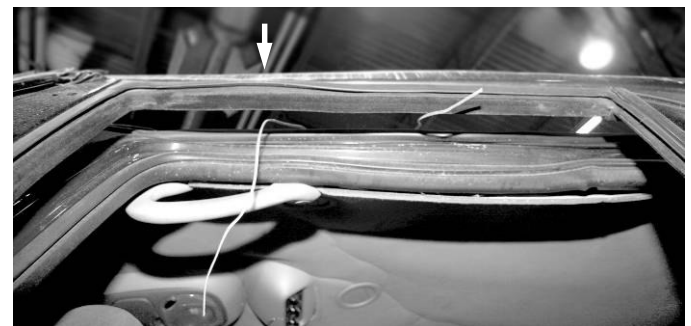
Figure 15. The forward portion of the top of the window frame was bent outward as a result of the partial ejection of the left arm of ATD 2L in the Expedition rollover test.

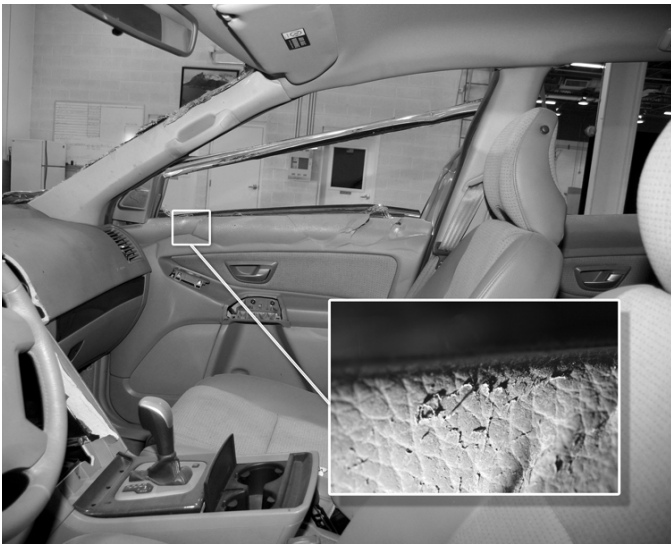
Figure 16. A scuff mark with upward and outboard smearing of the plastic was left on the beltline as a result of the ejection of ATD 1R in the Volvo rollover test.

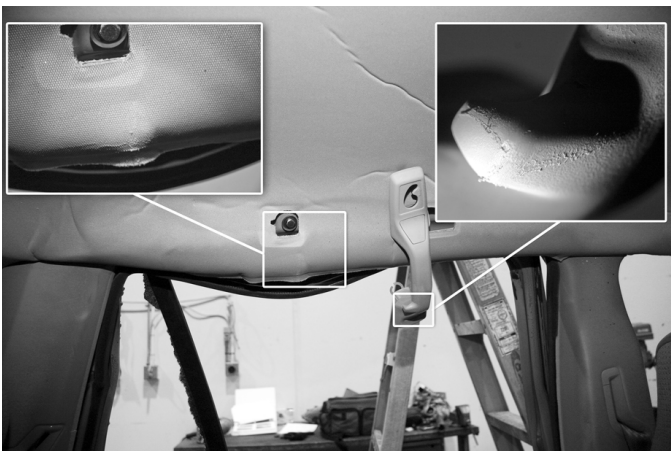
Figure 17. As a result of the ejection of ATD 2L in the Volvo rollover test, the grab handle was knocked outboard, leaving a scuff on the headliner and smearing the plastic on the outboard edge of the grab handle.

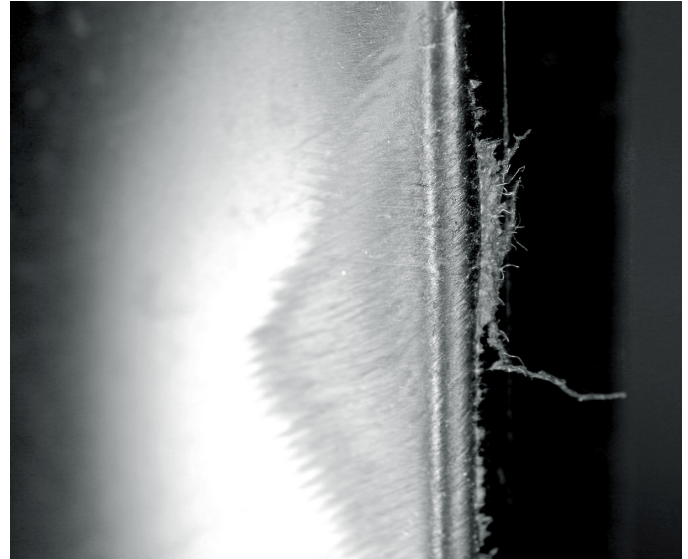
Figure 18. A fabric mark with smearing of the plastic in an outboard direction was left on the divider bar as a result of the partial ejection of ATD 2L in the Expedition rollover test.

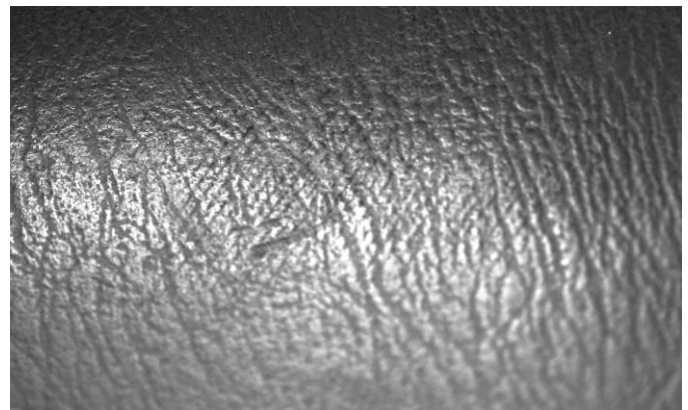
Figure 19. A fabric mark consisting of light diagonal abrasions was left on the rear fixed window lower plastic trim as a result of the ejection of ATD 3L in the Expedition rollover test.
